# In-rush Protection and Water Management

International Workshop on Mine Hazard  
Prevention and Control, 19-20 Nov 2013

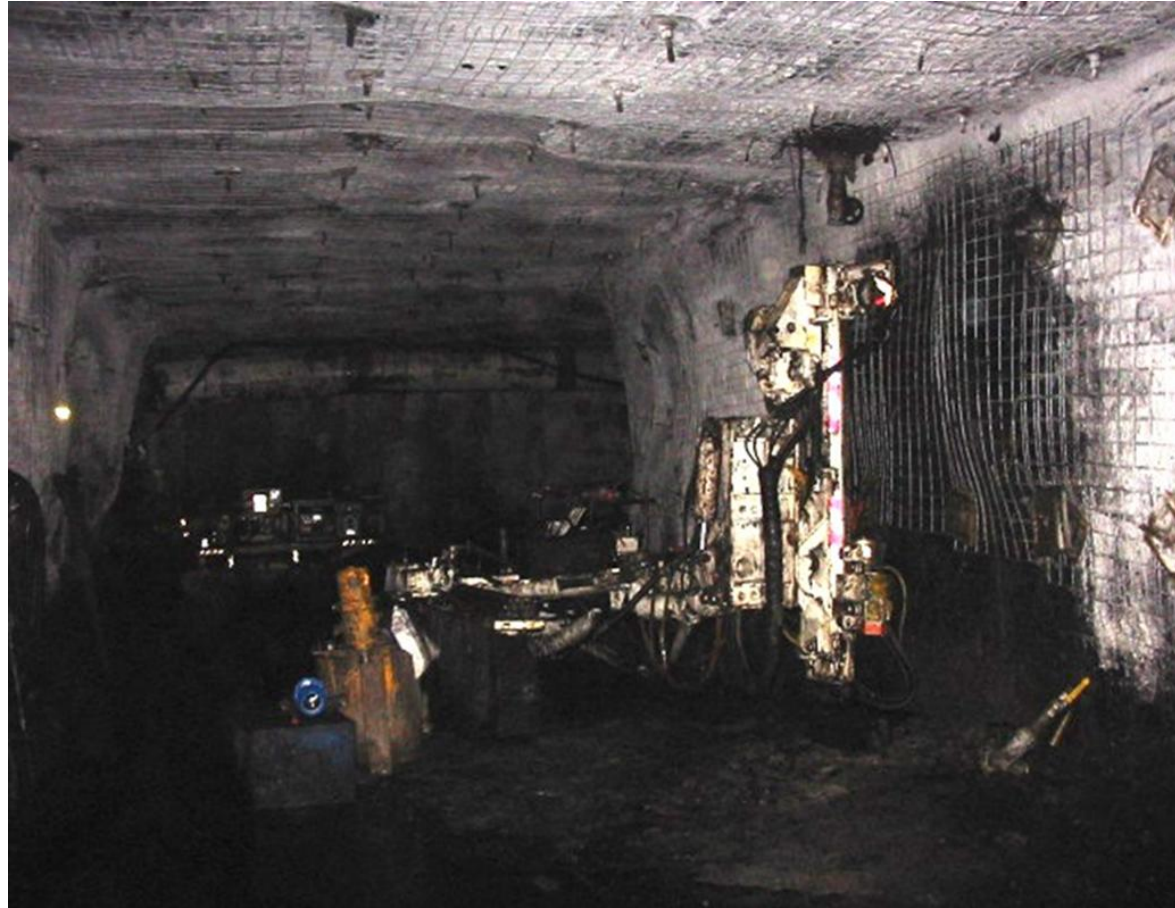
## Vertical Rotary Drilling

- Drill sites set up in each cut-through
- Standpipe installed up through the tuff band
- Up-holes rotary drilled to intersect and test location and water status of over-lying workings
- Up-holes reamed to 96mm if found to make water
- Connected to the mine drainage system to remove water from the mine
